Experimental analysis of ice sphere impacts on unidirectional carbon/epoxy laminates

Abstract

This work analyses the behaviour of carbon/epoxy unidirectional laminates subjected to high velocity impacts of ice spheres. To this end, ice projectiles were launched against composite laminates in a wide range of velocities (50–250 m/s). Two different ice diameters (40 and 50 mm) and two laminate thicknesses (4 and 6 mm) were considered. The internal damage was measured using both destructive and non-destructive techniques, which allow an accurate quantification of the delaminated area. Finally the influence of the different parameters considered on the damage of the laminate is analysed by means of a dimensionless variable.

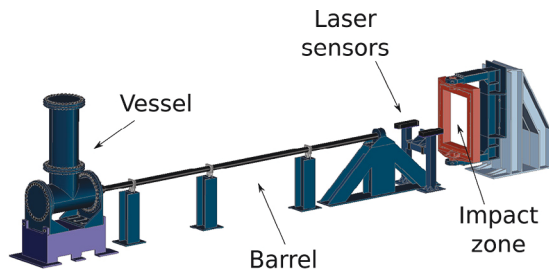
**Fig. 1.** One stage pneumatic launcher.

In order to perform the high velocity ice impact tests, a one stage pneumatic launcher with a 5 m long barrel and a 60 mm of calibre (Fig. 1) was used. The launcher uses compressed air to impel the projectile; the pressure used in the test can be varied, in order to reach different impact velocities. Two laser barriers are located at the exit of the barrel muzzle in order to measure the projectile velocity before impacting the composite target. Laminates were clamped using a steel frame located in front of the cannon, leaving a free span of 280×280 mm. Since no panel perforation was expected, a laser extensometer (MEL-M27L/20) was placed at the back of the composite coupon. It allows to measure the out-of-plane

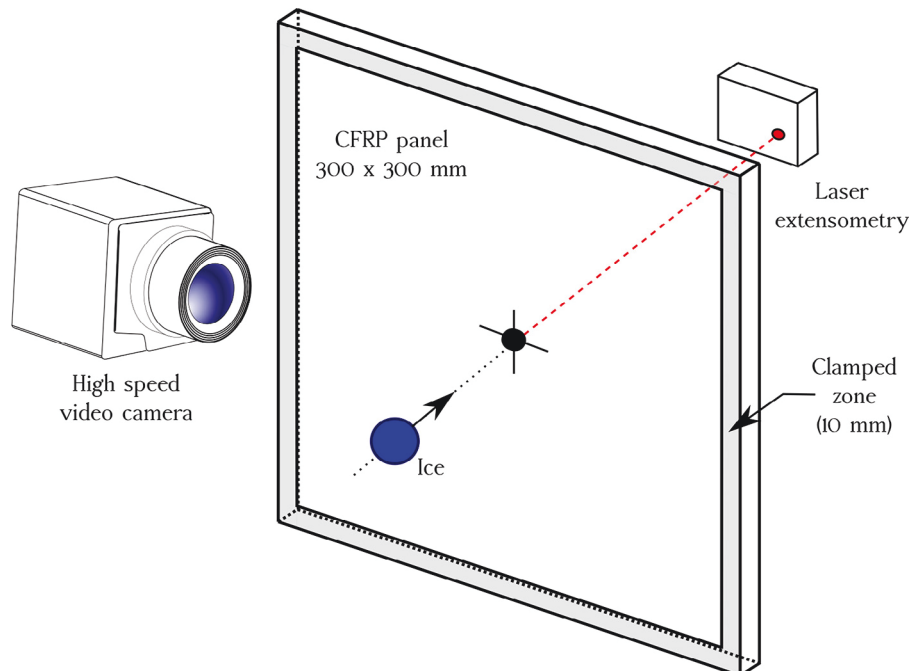
**Fig. 2.** Experimental scheme.

displacement of the laminate centre during the impact process; the maximum range of the laser is 20 mm, which is high enough to measure the laminate maximum deflection. The impact event has been recorded by means of a high speed camera (Photron Ultima APX); the lighting was provided by an HMI lamp. A setup scheme of the experiments can be observed in Fig. 2.

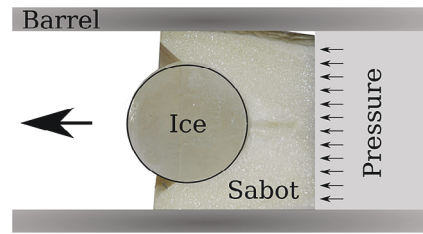
**Fig. 3.** Section of 40 mm diameter ice with sabot inside the barrel.

A sabot was developed to launch the ice due to the difference between the calibre of the barrel and the ice diameter. The sabot was made of polyurethane foam, which isolates thermally the ice (Fig. 3). In addition it also protects the ice during the acceleration in order to avoid the appearance of cracks. The aerodynamic design of the sabot allows to deflect its trajectory in order to avoid its impact on the target. Using this setup, the ice spheres impact perpendicularly to the plane of the composite laminate in a velocity range between 50 and 250 m/s.

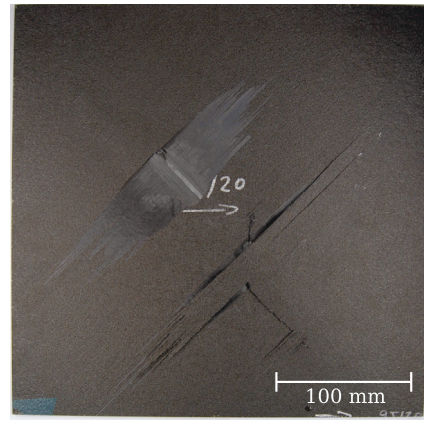
Fig. 5. Damage at front face in a 21 plies laminate impacted by a sphere of 50 mm at 200 m/s (1140 J).

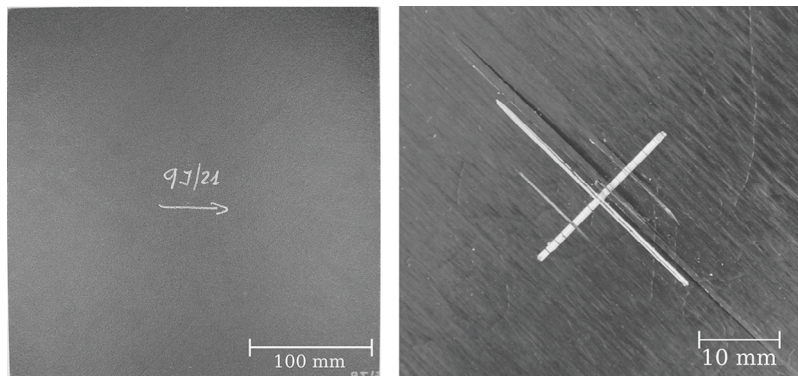
(a) No visual damage at front face

(b) Zoom of damage at back face

Fig. 4. Visual damages in a 4 mm plate impacted by a sphere of 50 mm at 154 m/s (675 J).

The impacted laminates only show barely visual external damages. The composite plates impacted at low velocity (or low kinetic energy) do not show any sign of damage in any of its faces; neither in its front face (where the projectile impacts), nor in its back face. As the kinetic impact energy increases, external damage appears firstly in the back face of the specimen in the form of fibre debonding (Fig. 4). Higher impact kinetic energy promotes external damages at the impacted face laminates, as can be shown in Fig. 5, where a 4 mm thickness laminate (impacted at ~ 1200 J) shows some fibre tows debonded; the back face of the laminate shows similar damages as previously described.

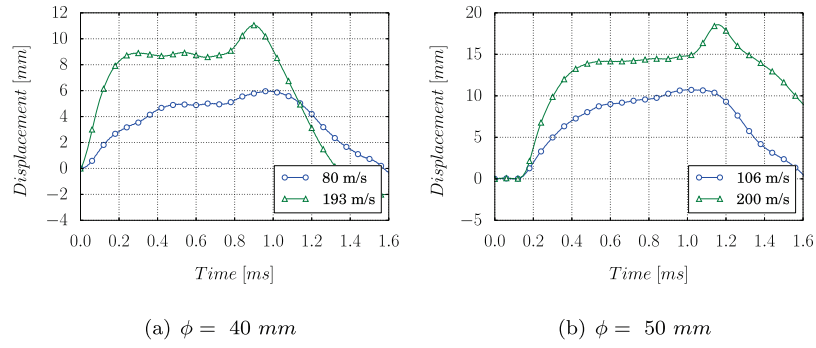
Fig. 6. Displacement out of laminate plane of the central point during the impact for 21 plies laminate.

The displacement of the centre of the plate, measured by the laser during the impact, is shown for different projectile diameters and velocities in Fig. 6. When the plates are impacted, the deflection grows until reaching a plateau and then decreases to zero at around 1–1.2 ms. As expected, the higher the impact velocity, the higher the deflection. It is important to note that impacts at higher velocities present a sudden increase in displacement at the end of the plateau. This kind of response is usually associated to a change in the stiffness of the composite plate. Since boundary conditions do not change during the impact test, it is reasonable to relate the reduction of the stiffness to the appearance of damage in the plate in the form of delamination. Finally, regarding the influence of the projectile diameter on the deflection, it is worth to mention that the same behaviour is observed; the only difference is that a larger diameter (and hence mass) promotes larger displacement values. Same trend with different values is observed for the 6 mm thickness laminates.

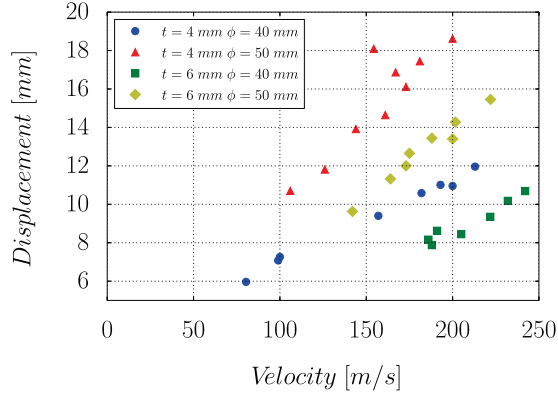
Fig. 7. Maximum displacement measured by the laser for the two plate thickness and different projectile diameter.

Fig. 7 summarizes the maximum values of out-of-plane displacement measured by the laser during the impacts. The displacement increases with the impact velocity; the combination of the bigger ice projectile and the thinner laminates induces the maximum displacements as expected. The relation between the displacement and the impact velocity seems to be linear with low spread; the sudden increase related to the internal damage

(previously described) is relatively small, and hence no appreciable change in the slopes of Fig. 7 can be observed.

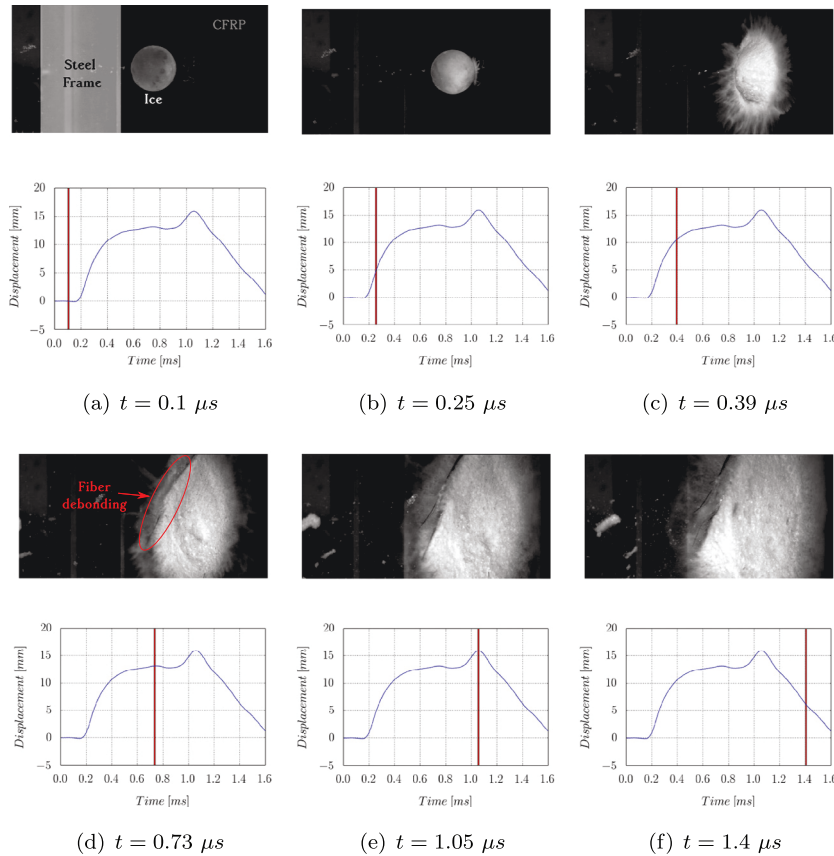
Fig. 8. Impact sequence frames and displacement history synchronized for an impact of 50 mm ice projectile diameter at 200 m/s (1140 J) against a 4 mm composite plate.

The impact tests were recorded using a high speed video camera in order to analyse the impact process and correlate it with the displacement response of the plate obtained by means of the laser extensometer. Fig. 8 shows different frames of an impact, synchronized with the measurements obtained by the laser extensometer (the example corresponds to a 50 mm ice projectile diameter impacting at 200 m/s (the impact energy of this test is $\sim 1140 \text{ J}$) against a 4 mm composite plate). The corresponding instant in the deflection curve is indicated by a vertical line. It is observed that, as soon as the ice projectile impacts the plate, it becomes completely

fragmented losing its transparency due to the appearance of new surfaces in the cracks that reflect the light [30]; at that instant the displacement starts to increase (Fig. 8(b)). Since the thickness reduction of the plate is negligible, the displacement of the front face and back face could be considered the same. At $t = 0.75 \mu s$ in Fig. 8(d) some fibre debonding can be distinguished at the upper left quarter of the composite plate (as indicated in the previous section). This kind of damage does not reduce significantly the stiffness of the plate, and the displacement measurement is not affected appreciably. In fact, a few microseconds later (Fig. 8(e)), the displacement history shows the sudden increase already commented; since no difference in the external damage is appreciated, the change of stiffness could be associated to an internal damage of the laminate. Finally, the last image of the impact process shows that once the maximum peak displacement is reached, the ice projectile is completely deflected in a direction parallel to the laminate surface, and the force performed tends to zero.

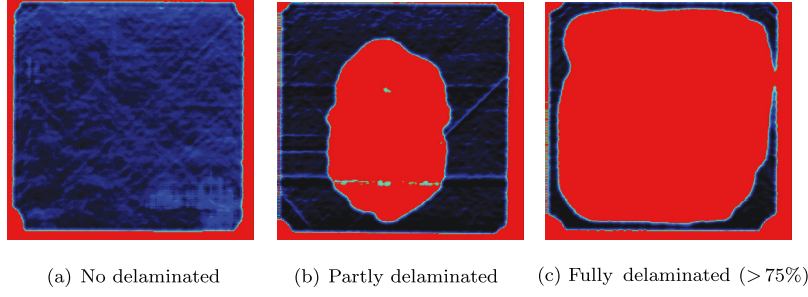
Fig. 9. Ultrasonic scan of laminates impacted at different velocities.

In order to study the internal damage of the plates, ultrasonic techniques were used before (to assure the panel integrity) and after the impact. Fig. 9 shows the C-scan inspection of different CFRP laminates; Fig. 9(a) depicts a 6 mm plate impacted by 40 mm ice projectile at 150 m/s in which no delamination (depicted in blue) is observed; Fig. 9(b) and (c) show plates which contain different amount of delamination (depicted in red). The C-scan results of most of the impacted plates show extreme situations; no delamination or a great amount of delamination appears, only a few plates show partly delamination as can be observed in Fig. 9(b). The composite panels that exhibit delamination correspond to the ones that show a sudden increase in the deflection (previously explained).

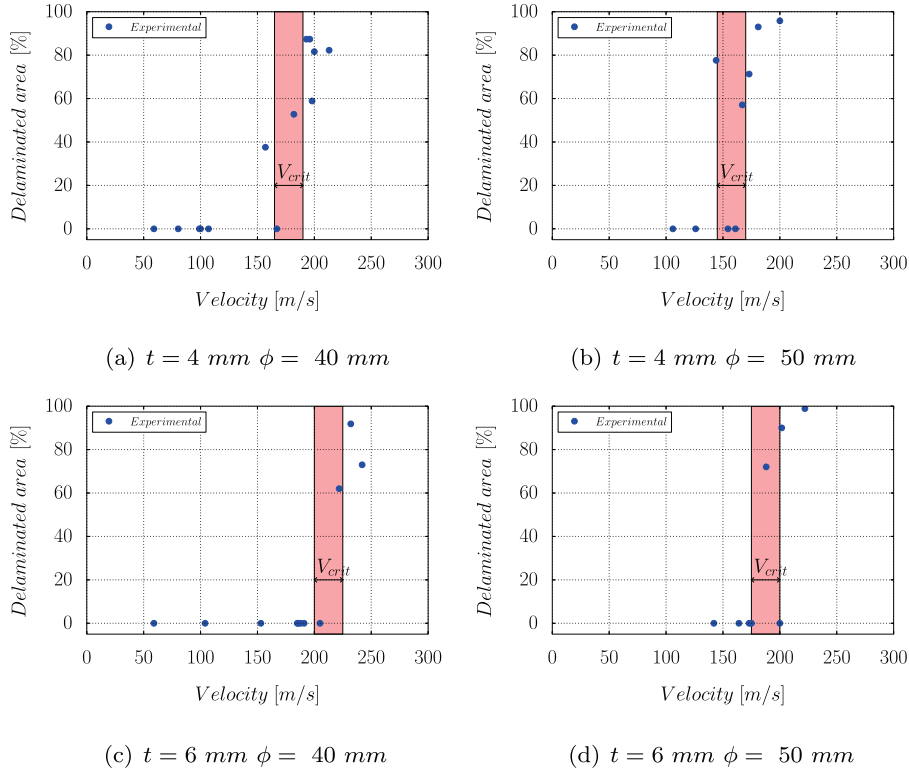
Fig. 10. Delaminated area against impact velocity for the two plate thickness and different projectile diameter.

The summary of delaminated area versus the impact velocity for both thicknesses and ice projectile diameters is shown in Fig. 10. These graphs show that the transition between zero delamination

to full delamination (delaminated area greater than 75%) occurs in a narrow range of velocities. In fact it is possible to define a critical velocity (for each ice diameter and composite thickness combination) that establishes this sudden transition.

Delamination is the main damage mechanism that composite laminates exhibits. In order to analyse under which circumstances it appears, Table 3 summarizes the critical velocities (V_c) and the critical kinetic energies (KE_c) needed to promote this type of failure. The critical velocity is obtained using Fig. 10, by performing an average of the marked zone (which corresponds to the abrupt transition from no delamination to full delamination). For all the combinations of ice diameter and composite thickness, the impact

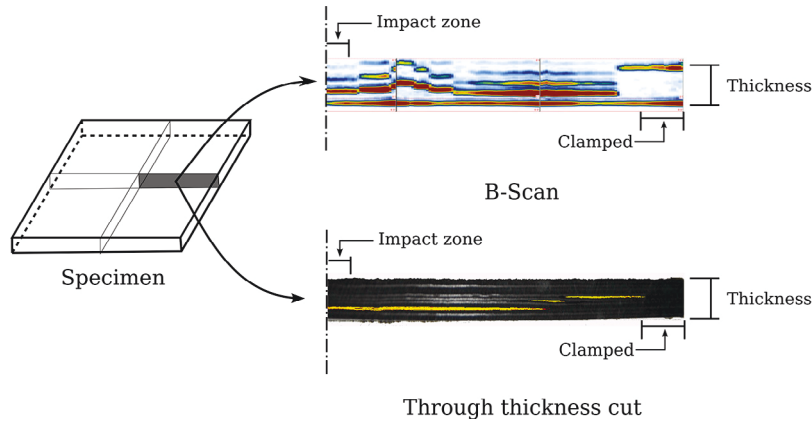
Fig. 11. B-Scan and through thickness cut of a 4 mm thickness composite plate impacted by a 40 mm diameter ice projectile at 193/s (540 J).

In order to study the location of internal damages and confirm that the main damage produced corresponds to delamination, B-scan analysis as well as through thickness cuts have been performed. Fig. 11 shows both inspections for a section at the middle of the laminate specimen; in the B-scan the delamination is depicted in red and in the through thickness it is highlighted in yellow. Both images show that the delamination appears mainly between two plies that are close to the back face; in addition it is possible to observe that the delamination zone ends close to the clamping area. Since the identified delamination is located approximately at one-third of the laminate thickness (close to the rear face), a reduction of the laminate stiffness is expected, which could explain the sudden increase in the deflection time history curves.

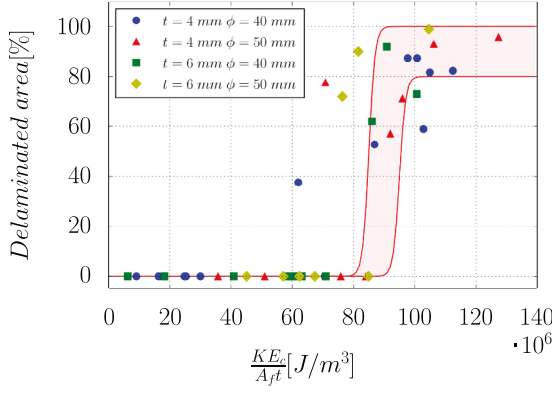
Fig. 12. Delaminated area versus the non-dimensional variable ξ .

In order to analyse if this constant defines the transition between no delamination to full delamination with accuracy, Fig. 12 shows this transition; in this plot the x axis is the variable $KE/(A_f t) = \xi$ (where KE is the kinetic energy of the impact) and the y axis is the delaminated area which varies from 0% to 100%. The graph confirms that the variable ξ describes with enough accuracy if a determined test promotes delamination or not. The constant C_1

appears to be the value that indicates the transition between no damage and full damage.

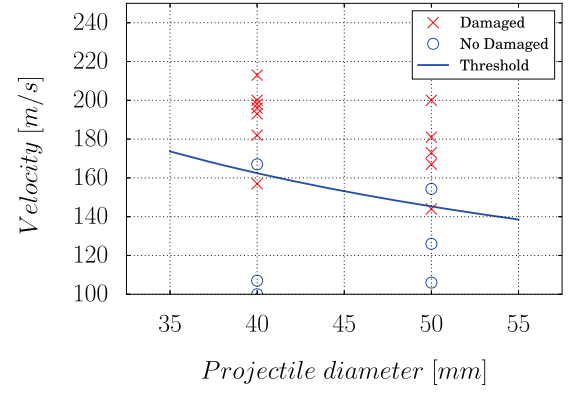
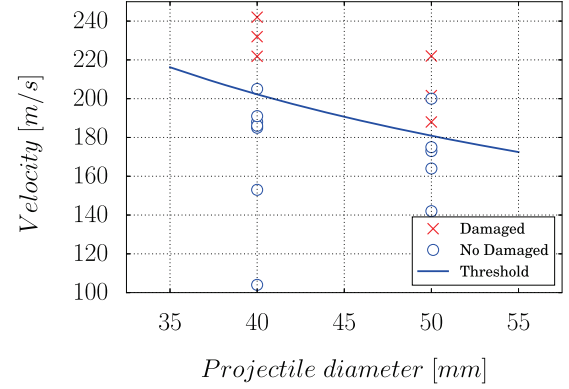
(a) 4 mm thickness laminate

(b) 6 mm thickness laminate

Fig. 13. Experimental and proposed damage threshold for both laminate thicknesses and ice diameters.

where ρ is the ice density. The corresponding value for ξ^* at which the transition occurs between no delamination and full delamination is $\xi^* \sim 3 \cdot 10^4$ (using $G_{IIc} = 750 \text{ J/m}^2$ [42]). Eq. (3) could be used to define a threshold between no delamination to full delamination for any variable. In particular it will be interesting to check if it defines adequately the critical velocity, which in fact is the impact velocity threshold. Fig. 13 shows the experimental tests accomplished in the current work, plotting the impact velocity in the y axis and the projectile diameter in the x axis; the tests in which delamination appears are represented with an "x" and the ones that do not are represented by a circle. The blue line is the Eq. (3) in the form:

It is clear that this function divides the tests in the two aforementioned groups (Fig. 13) for both the projectile diameters analysed.

The tests in which there is delamination remain above the line, whereas the non-delaminated tests stay below it. As shown in Fig. 10 the critical velocity is a range rather than an exact value; this is the reason why, due to the experimental dispersion, there are two specimens slightly misplaced. As expected this threshold line decreases as the projectile diameter increases. Comparing the two figures (for 4 and 6 mm laminate thickness respectively), the critical impact velocity increases with the laminate thickness.

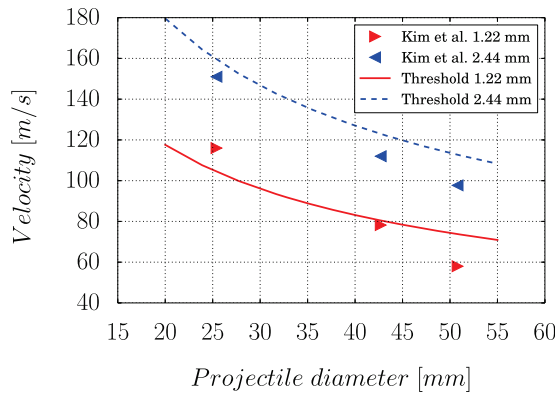
Fig. 14. Comparative thresholds for the experimental results obtained by Kim et al. [31] and the proposed in this article.

The proposed equation has proven to be valid in the range of parameters studied in the present work. In order to study if it is valid in a wider range, the experimental results from Kim et al. [31] are going to be used. In this work the composite panel size is $305 \times 305 \text{ mm}^2$ (free span of $260 \times 260 \text{ mm}^2$) and the ice diameters studied are $\phi = 25.4, 40.7, 50.8 \text{ mm}$. The material of the panels was the same as that used in this work, but with another architecture (woven 8 harness satin); the thickness was also different 1.22 and 2.44 mm. Fig. 14 represents the threshold velocity as function of the ice projectile diameter; in this graph the triangular markers correspond with the threshold velocities obtained by Kim et al. [31], and the lines with the equation proposed in the current work (Eq. (4)). Appropriate values were used for the variables L (obtained from the article of Kim et al. [31]) and G_{IIc} (obtained from Ref. [42,43]). It is clear that the trend is the same, and that some differences exist although they are within reasonable limits taken into account the simplicity of the equation, and that some differences exist between the experimental setups of the two works.

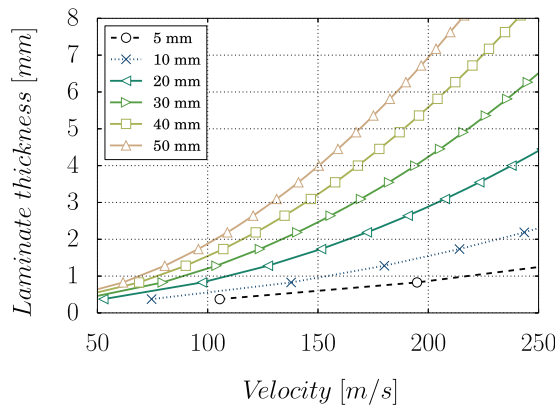
Fig. 15. Proposed safe design curves for unidirectional AS4/8552 ($300 \times 300 \text{ mm}^2$) against ice sphere impacts.

The data and the analysis presented in this study for different laminate plates and different ice projectile diameters allow proposing a guidance in safe design for composite plates against ice sphere impact. To this end, using the aforementioned equation it is possible to define threshold design curves, which are represented in Fig. 15. In this graph, the critical laminate thickness is represented in the y axis, and the impact velocity in the x axis; different curves exist for the different ice diameters. For a given ice diameter and impact velocity, the graphs define the critical laminate thickness where a sudden transition between no delamination to full delamination occurs. For instance the critical laminate thickness for a 40 mm ice diameter projectile impacting at 150 m/s will be 3 mm. Hence a thickness of 4 mm (3 mm promotes damage) could be a good start point to perform more accurate simulations or perform experimental tests.
